## SMALL CRATER EXPEDIENT REPAIR TEST

KENNETH J. KNOX  
ENGINEERING RESEARCH DIVISION

AUGUST 1980

FINAL REPORT  
JULY 1979 — AUGUST 1979

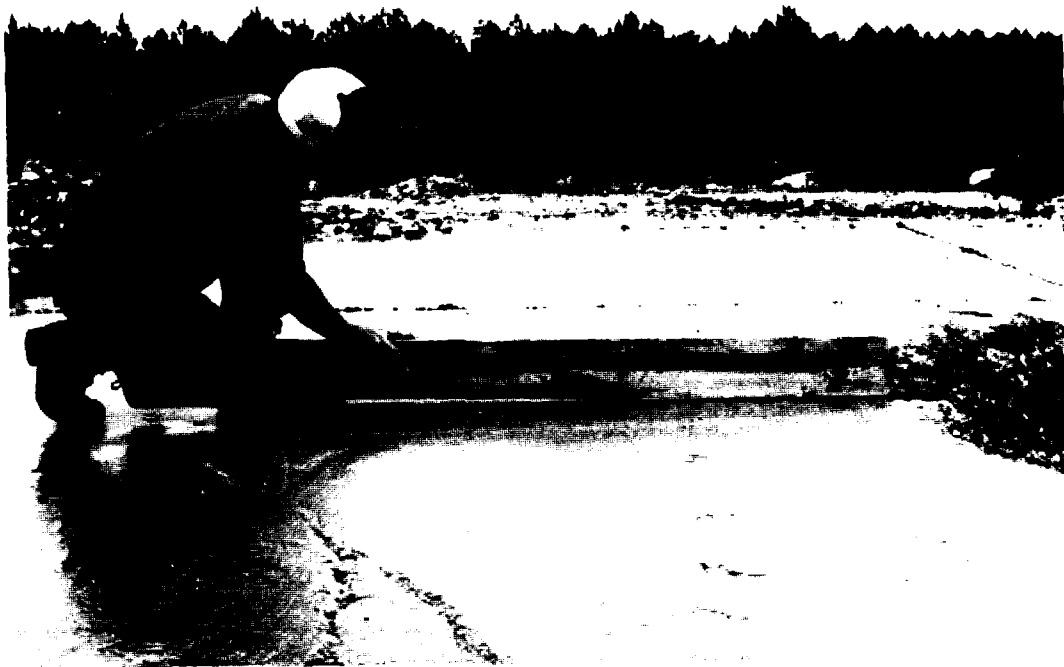
Figure 23. Checking for Upheaved Pavement

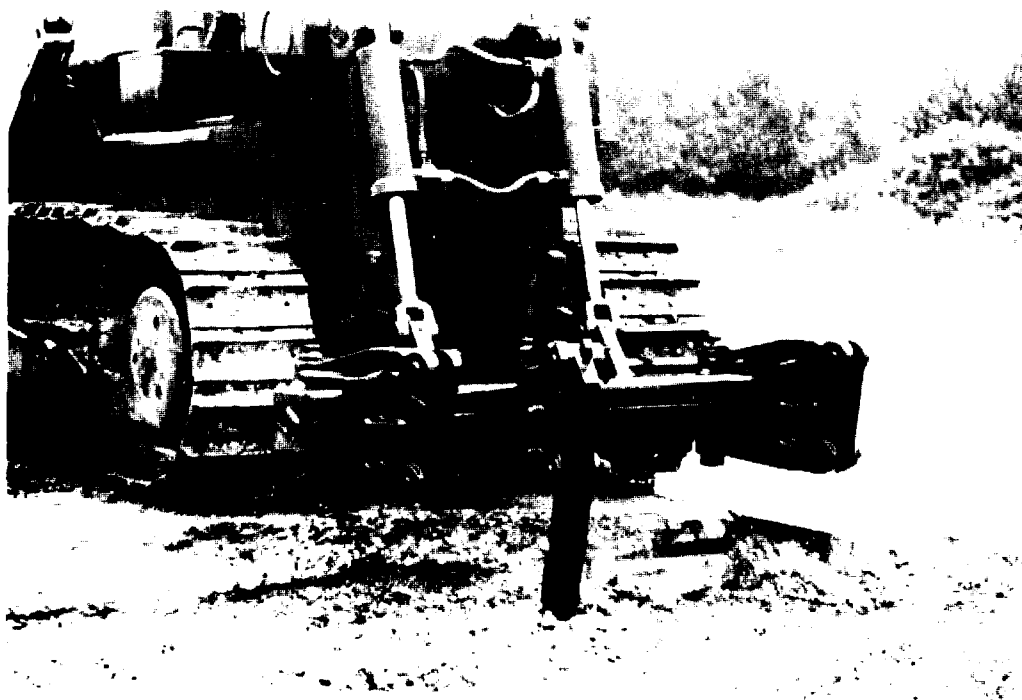
Figure 25. Removing Upheaved Pavement With the Ripper Tooth

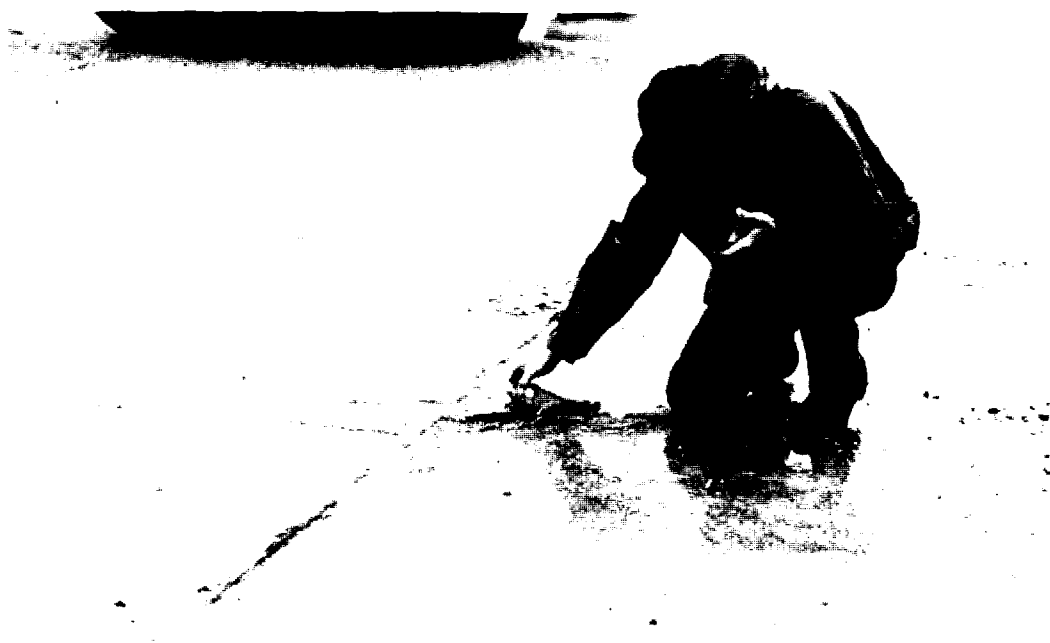
Figure 27. Concrete Spall Caused by the Vibratory Roller

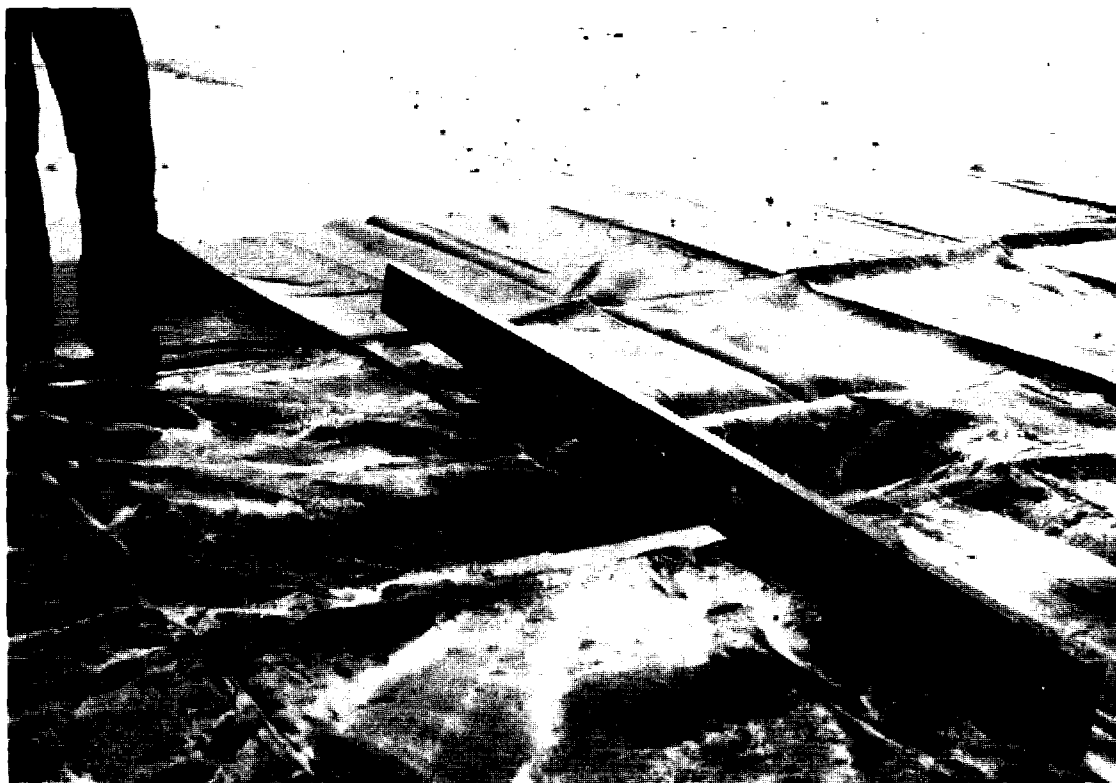
Figure 53. Rutting Failure on Crater 1

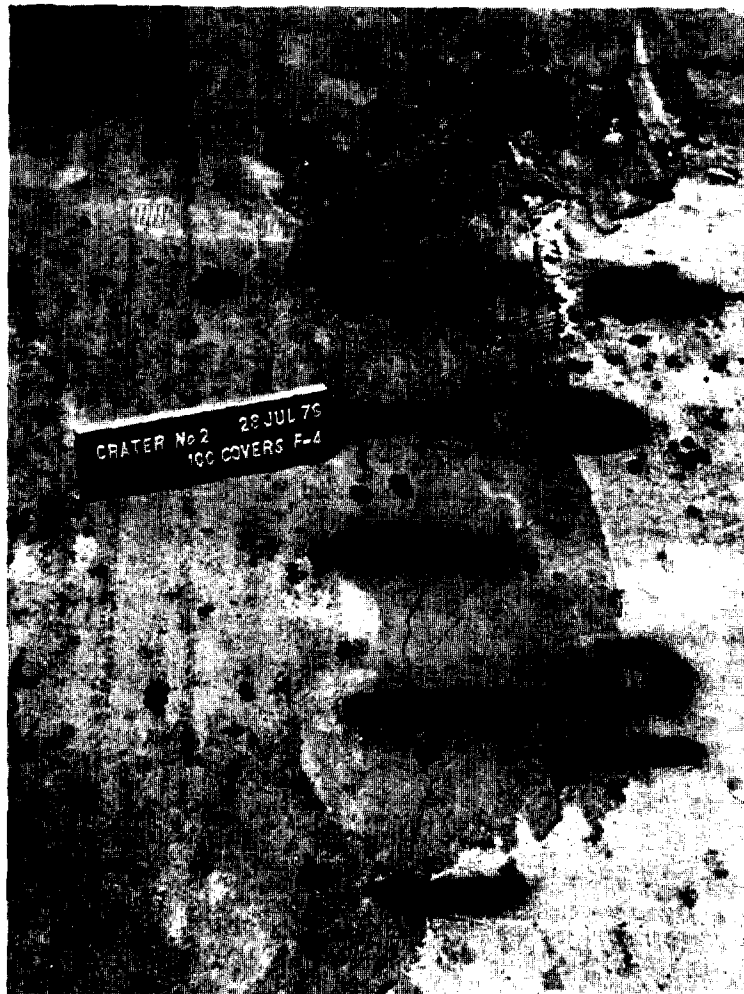
Crater 2, the practice polymer-concrete repair, developed minor cracks and spalls along the edges of the repair during the early loadcart coverages, as shown in Figure 54. The repair also deflected elastically under the loadcart wheel load. A maximum 0.7 inch of permanent deformation occurred in the main traffic area during the first 50 coverages (480 passes) of the loadcart, increasing only to 0.8 inch after 150 coverages. Hence after the initial deformation of the polymer concrete repair, little further deformation occurred.

Figure 54. Spalled Polymer-Concrete - Crater 2

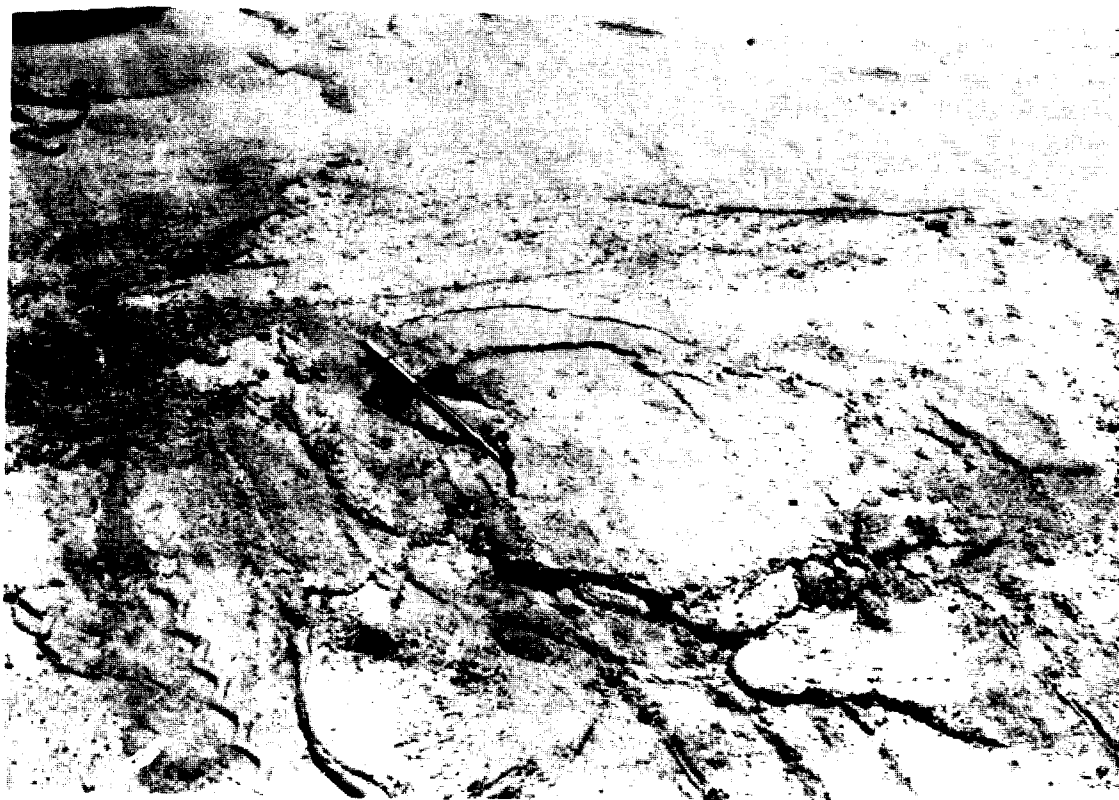
Figure 55. Quality Control Failure on Crater 4

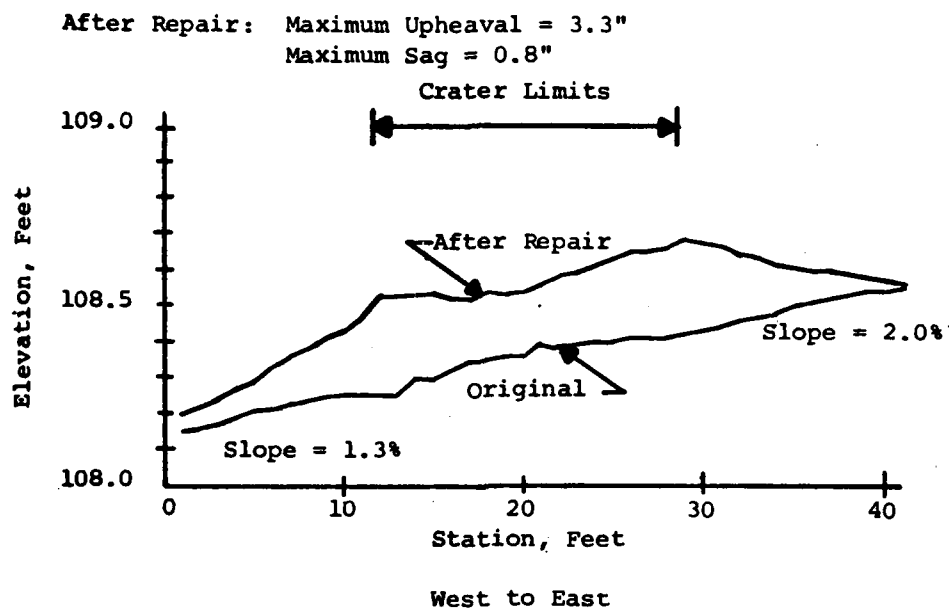
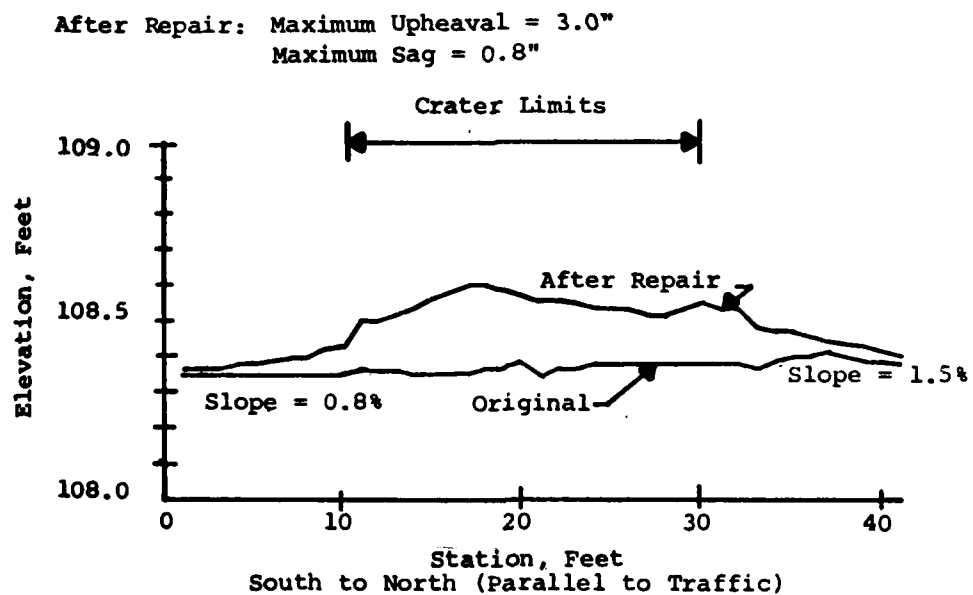
Figure 56. Crater 1 Profiles

After Repair: Maximum Upheaval = 1.6"    150 Coverages: Maximum Upheaval = 1.3"  
 Maximum Sag = 1.0"    Maximum Sag = 1.0"

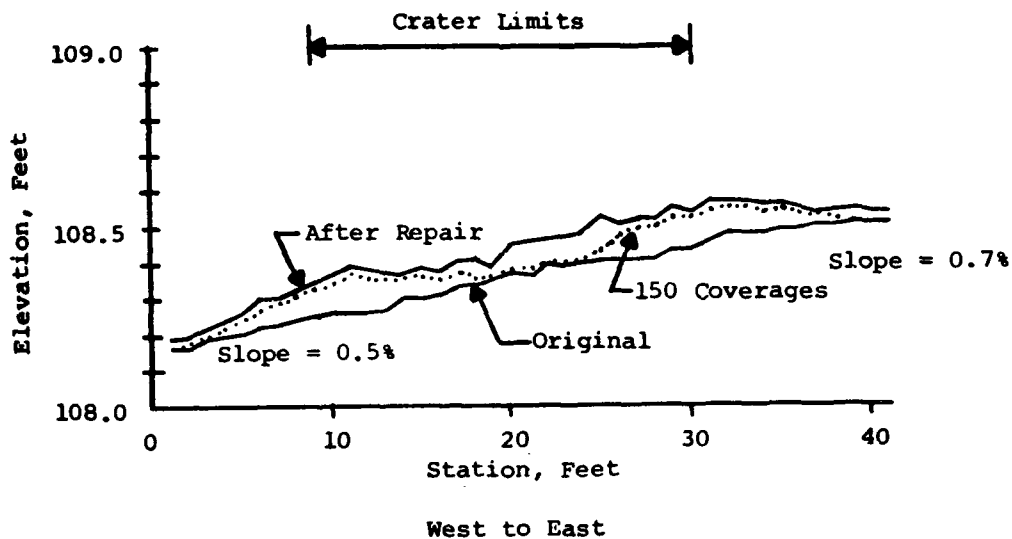
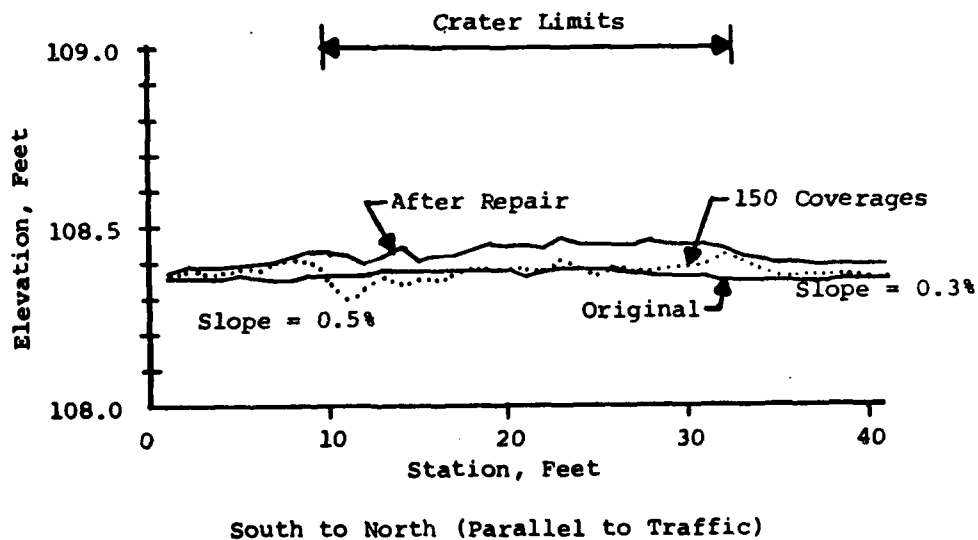
Figure 57. Crater 2 Profiles

After Repair: Maximum Upheaval = 1.2"    150 Coverages: Maximum Upheaval = 0.8"  
 Maximum Sag = 0.5"    Maximum Sag = 1.4"

**After Repair:** Maximum Upheaval = 1.4"      100 Coverages: Maximum Upheaval = 1.3"  
Maximum Sag = 0.7"      Maximum Sag = 2.6"
